Case 355 : Narrative

Case Vehicle (A): 2000 Toyota	Vehicle (B): 2002 Gillig
Type: Corolla, 4-door sedan	Type: Transit bus
Driver: 23-year-old male	Driver: 26-year-old male
CDC: 11-FYEW-3	CDC: 99-0000-0

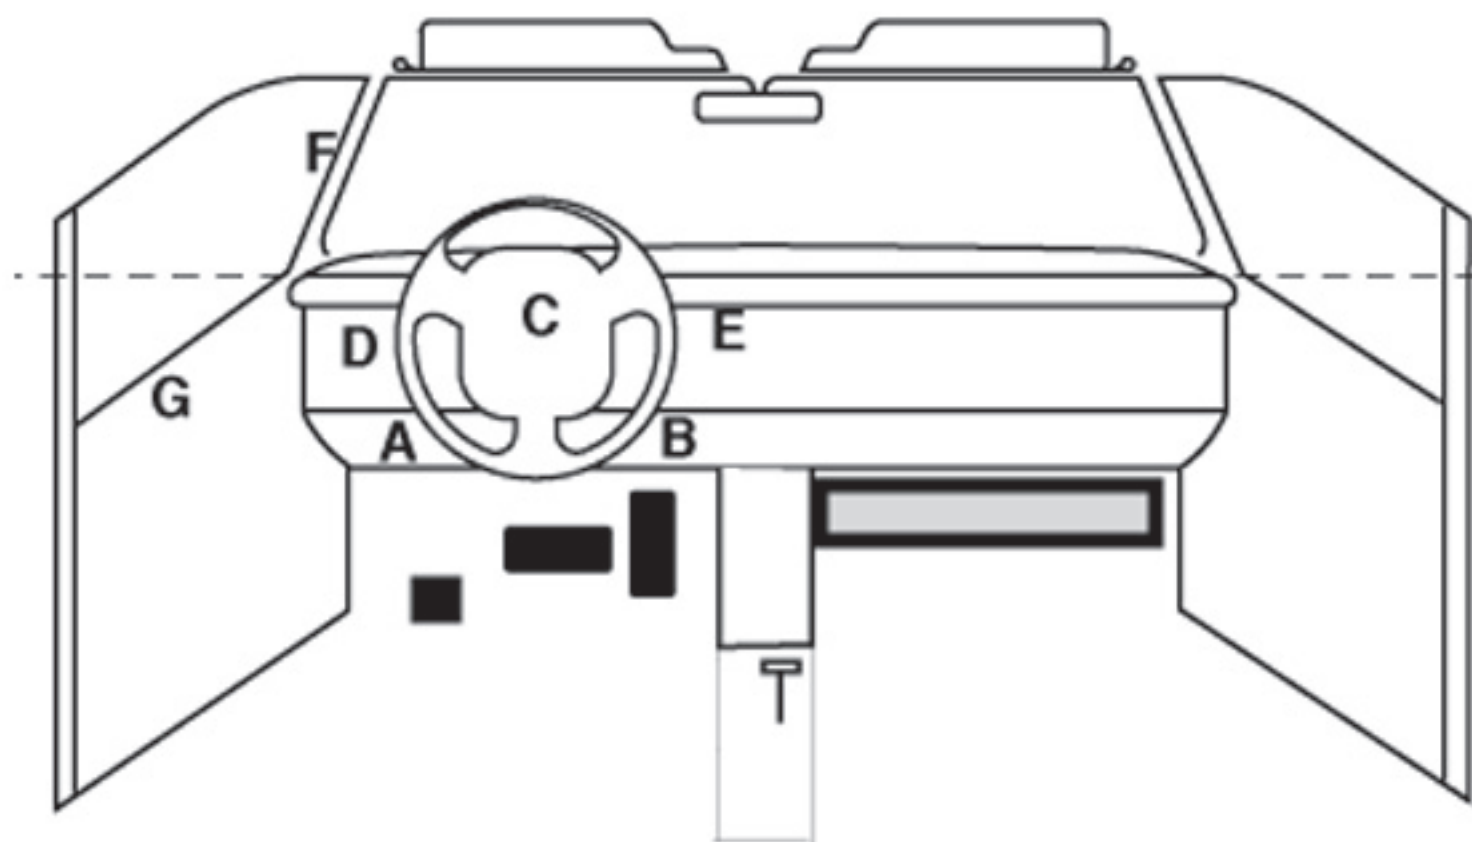
Contact	Interior Component Contacted	Occupant No. if Known	Body Region if Known	Supporting Physical Evidence	Confidence Level of Contact Point
A	Knee bolster	1	Left knee	Scuff mark	1
B	Knee bolster	1	Right knee	Scuff mark	1
C	SW airbag	1	Face	Blood transfer	1
D	IP	1	Chest	Scuff mark	2
E	IP	1	Unk.	Cloth transfer	2
F	A-pillar	1	face	Blood transfers	1
G	LF door	1	Unk.	Scuff marks	1
H					
I					
J					
K					
L					
M

A = knee bolster, scuff mark

B = knee bolster, scuff mark

G = driver door panel, scuff marks, deformed

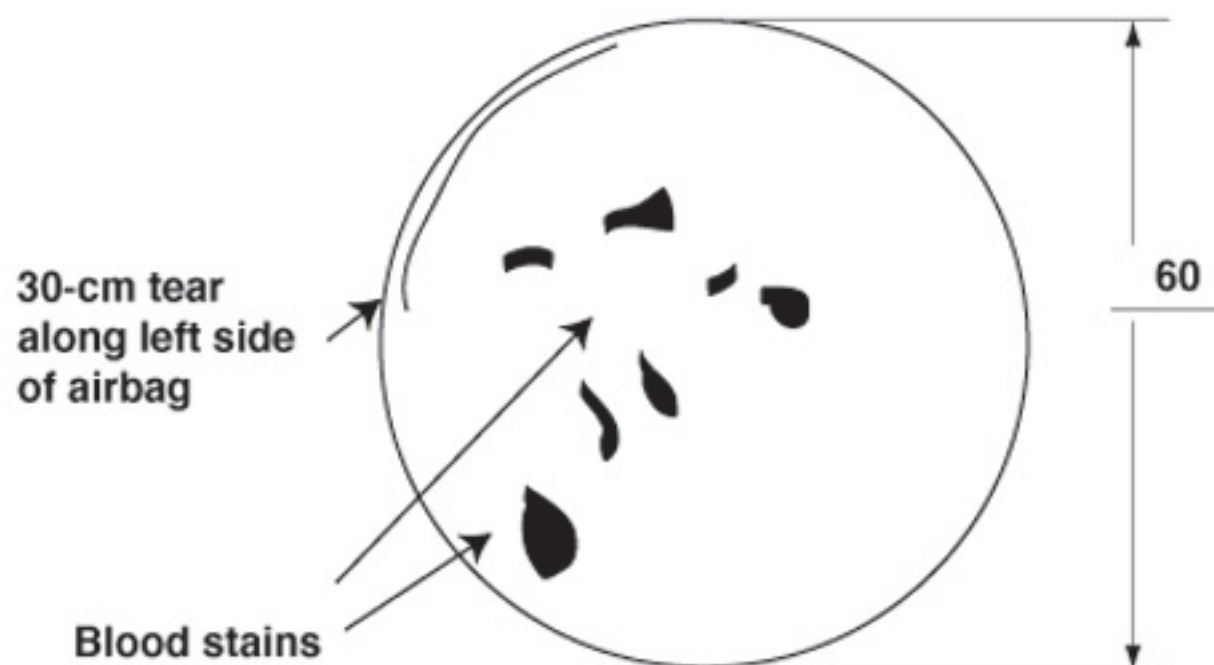
Driver Airbag

Vents: ☒ Y ☐ N
if yes, how many: 2

Tethers: ☒ Y ☐ N
if yes, how many: 2

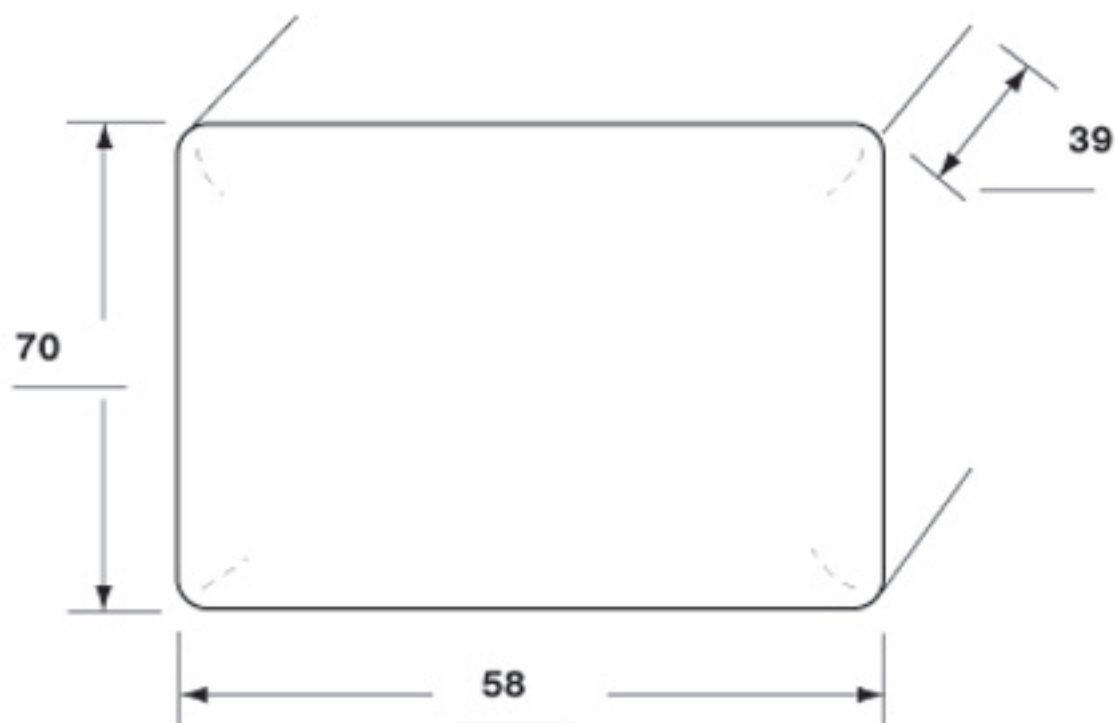
Passenger Airbag

Vents: ☒ Y ☐ N
if yes, how many: 2

Tethers: Y ☒ N ☐
if yes, how many: 0
